# *Navigating Regulations and Best Practices for Inspection and Maintenance of Stormwater Management Facilities*

**Nicholas Macdonald**  
**Business Development and Project Engineer**

**AQUALIS**

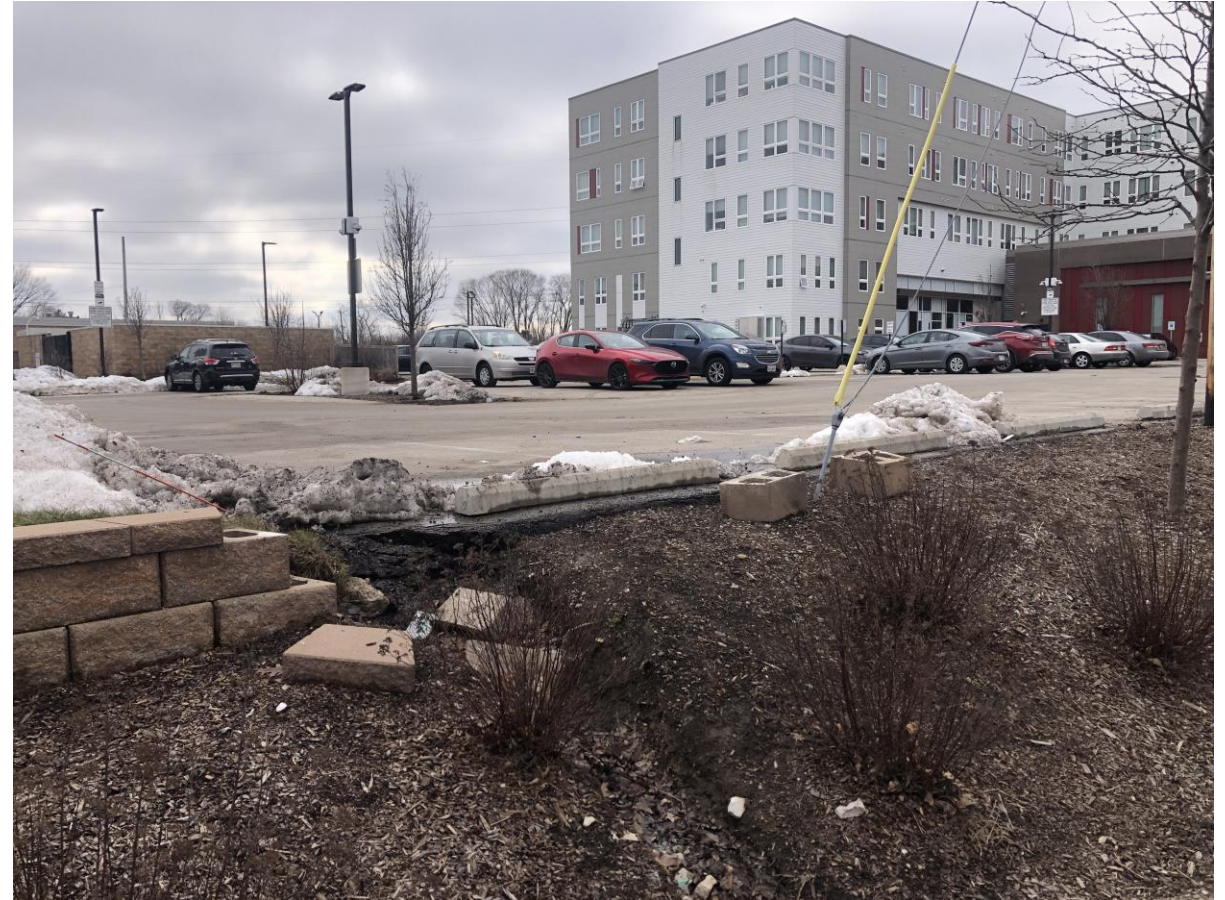
# Inspection Observations (Common)

- Rip-rap channels are washed out
- Accumulated sediment in catch basins
- Site litter and erosion
- Sediment accumulation at pond bottom
- Lid stuck on structures due to paving
- Subgrade failure in paver area
- Wildlife (geese, raccoons, and beavers)
- Animal burrows/dens in pond side slopes
- Overgrown vegetation surrounding BMP
- Unlocked gates to BMP
- Trench drain full of debris
